NAVAL POSTGRADUATE SCHOOL MONTEREY CALIF
BALLISTIC DAMAGE OF GRAPHITE-EPOXY PLATES.(U)
JUN 77 G A EATON

BALLISTIC DAMAGE OF GRAPHITE-EPOXY PLATES

George Arthur Eaton

June 1977

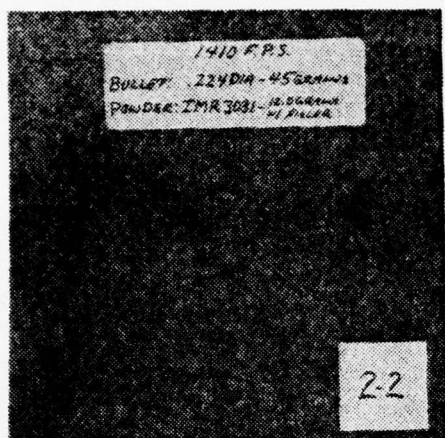
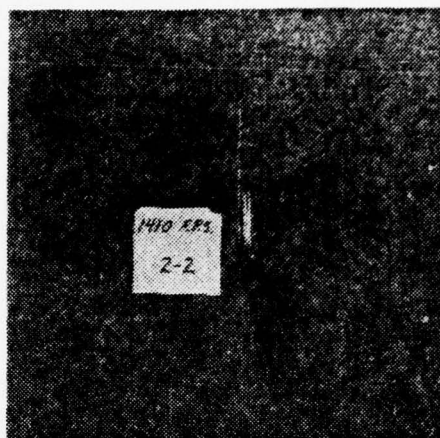
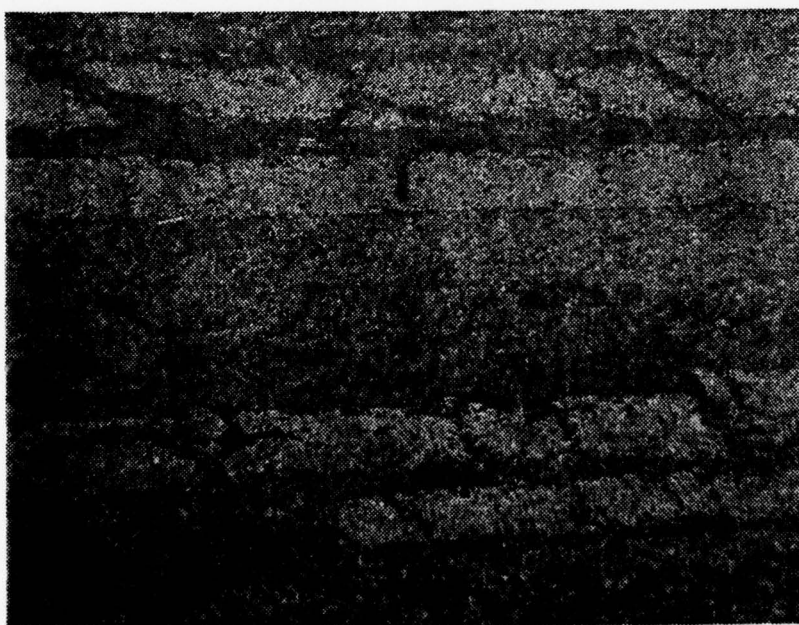
Figure 6 - MICROGRAPH OF SPECIMEN DAMAGED AT 1410 FPS

During the first test series the damaged specimens were cut transversely through the center of the hole, and a section along this line was removed for examination. These samples were mounted in cold-set plastic and polished for microscopic examination. Figure 4 shows a specimen ready for the microscope. The samples were examined and photographed at a magnification of 80X. Typical results are shown in Figures 5 through 11.

When a graphite-epoxy plate is subjected to ballistic damage, the resulting hole is round but not smooth, and the material at the edge of the hole is delaminated. Fibers in the outer lamina on the exit side, which were broken by the passage of the projectile, tend to delaminate and separate, and this damage extends for some distance from the hole in the fiber direction. Fibers which are not broken by the projectile, on the other hand, do not delaminate, except perhaps in the immediate vicinity of the hole. In addition, only fibers from the outermost lamina delaminate and separate; fibers from the 45° laminae, although broken, did not delaminate, except in the immediate vicinity of the hole. Thus the damaged area is roughly elliptical in shape, with the major axis in the direction of the fibers of the outer exit-side lamina. Figures 23 and 24 show the variation of damage area with projectile velocity. As can be seen, the damage area decreases as velocity is increased. In addition, at low velocity the separation of the fibers was very pronounced. As the velocity of the projectile increased up to the maximum tested velocity of 4000 feet per second, the separation of the fibers became less but was still visible.

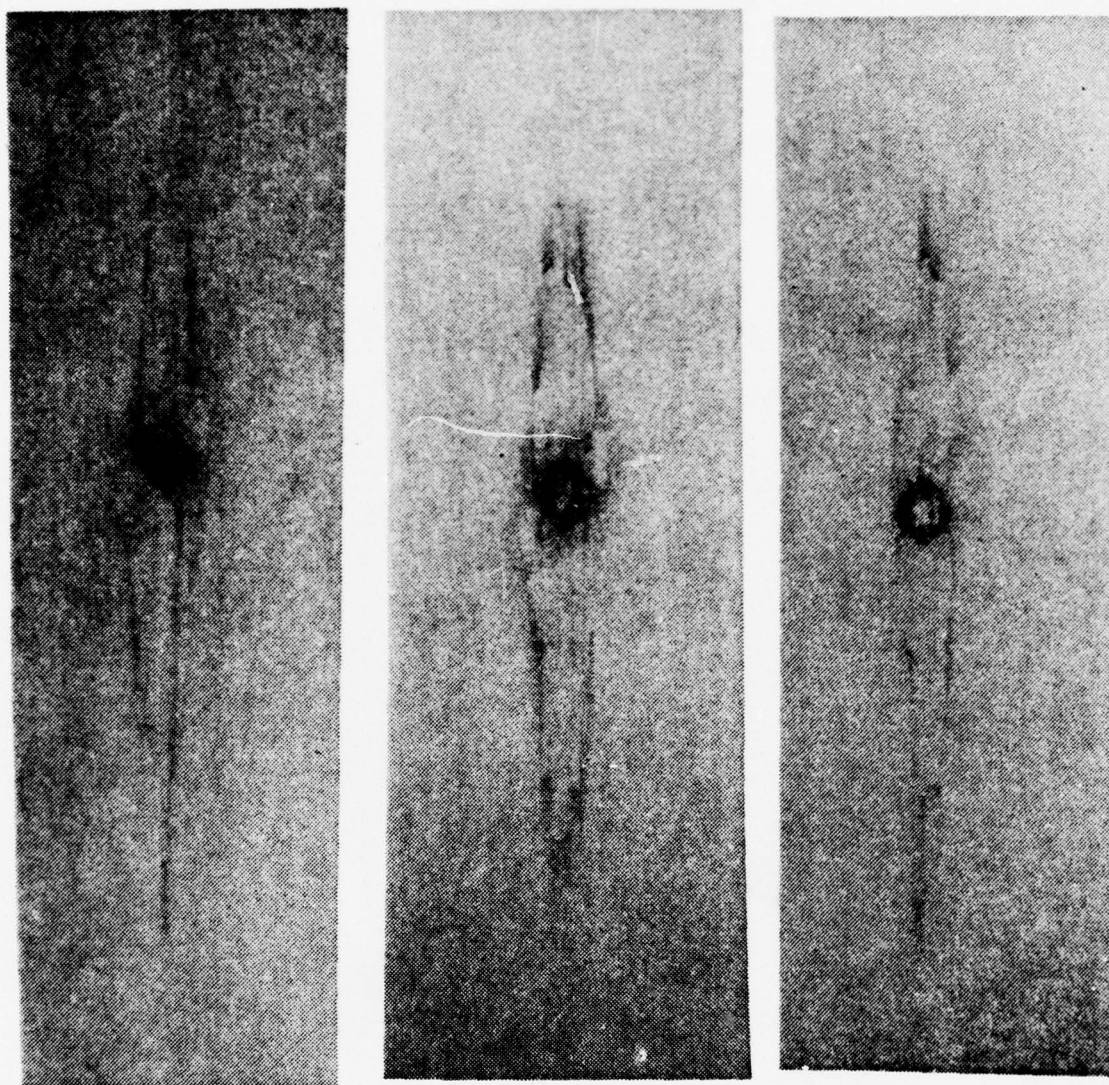
Figure 15 - X-RAYS (WITH RADIO-OPAQUE DYE) OF DAMAGED SPECIMENS

dye (a 29% solution of iodine in meglumine diatrizoate and sodium diatrizoate), was injected into the damaged area. This solution greatly increased the x-ray absorption where present, and thus improved the contrast dramatically. The resulting x-ray photographs are easily readable, even by the untrained observer. Figures 12, 13, and 14 compare both x-ray and light photographs of the same specimens, while Figures 15 through 19 show x-ray photographs of the specimens used in the final test sequence. Note that the x-ray photographs show a dark ring of delamination around the hole as well as splitting and delamination in the 0° direction. This delaminated ring was confirmed by sectioning and microscopic examination.

A. DAMAGE AT 980 FPS B. DAMAGE AT 993 FPS C. DAMAGE AT 1046 FPS

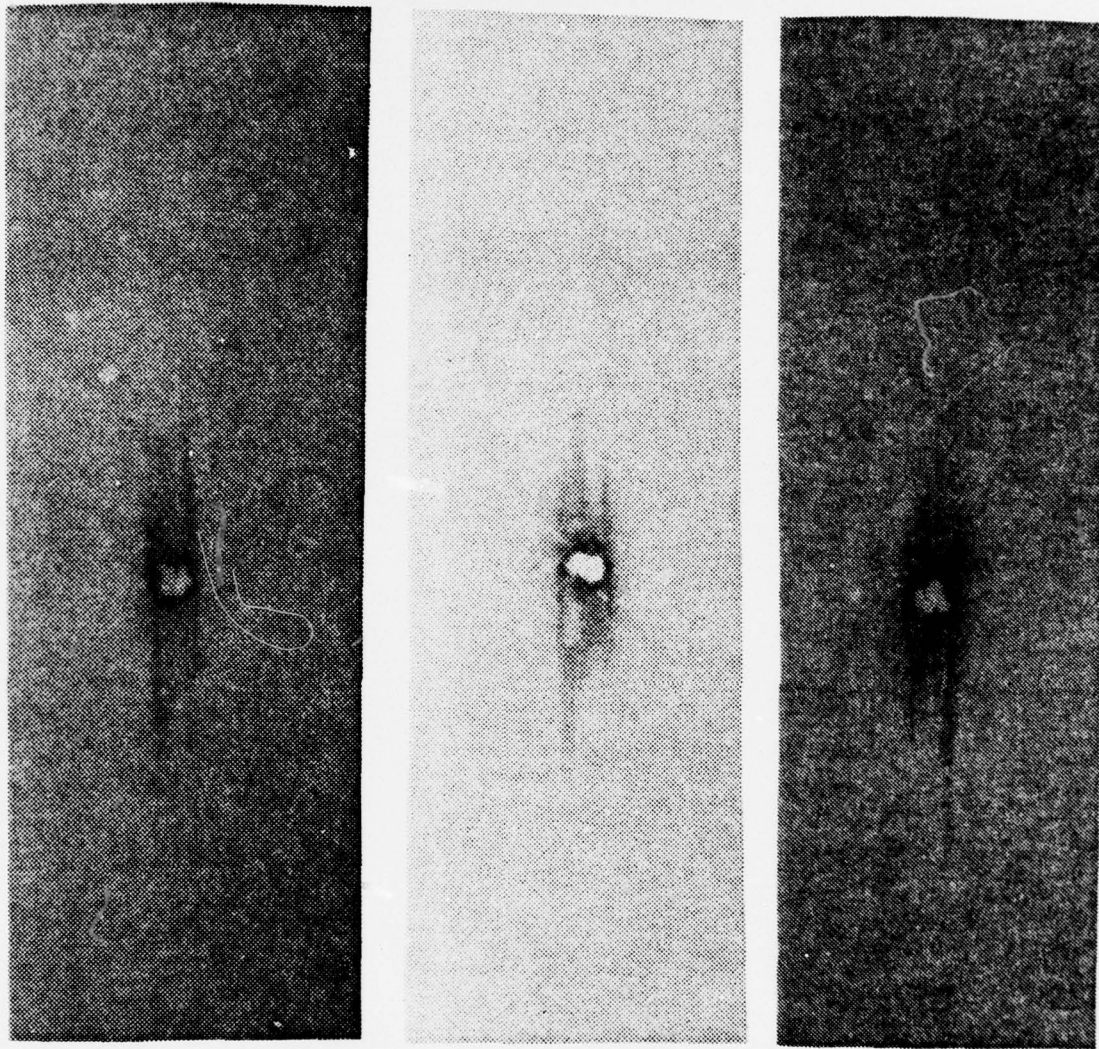
Figure 16 - X-RAYS (WITH RADIO-OPAQUE DYE) OF DAMAGED SPECIMENS

A. DAMAGE AT 2033 FPS B. DAMAGE AT 2058 FPS C. DAMAGE AT 2031 FPS

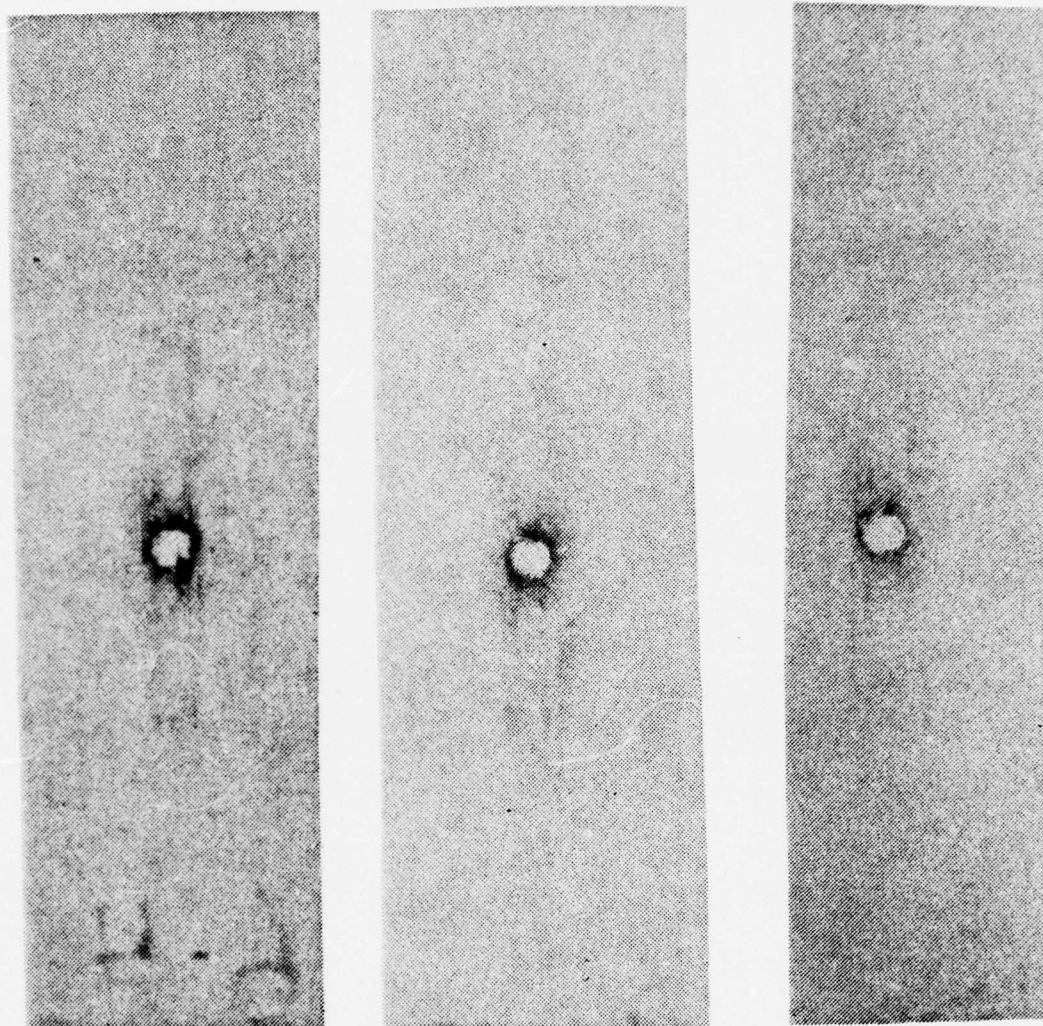
Figure 17 - X-RAYS (WITH RADIO-OPAQUE DYE) OF DAMAGED SPECIMENS

A. DAMAGE AT 2982 FPS B. DAMAGE AT 3026 FPS C. DAMAGE AT 3098 FPS

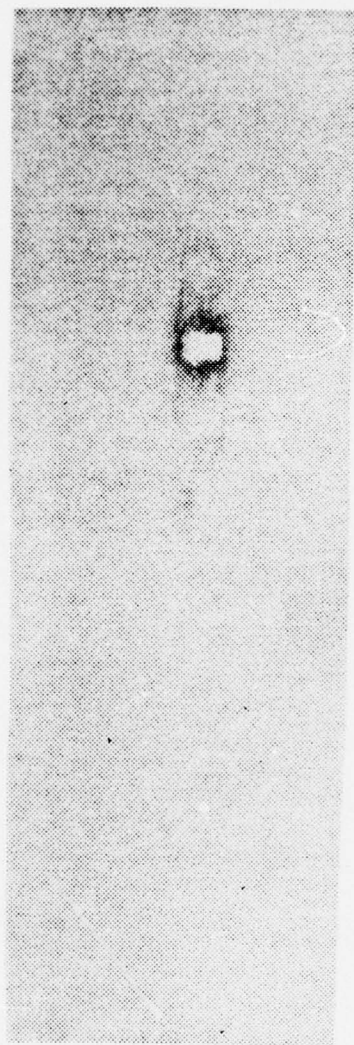
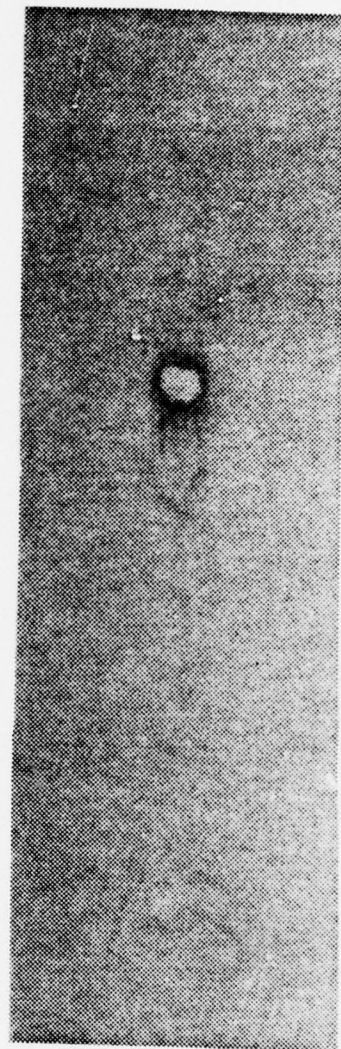
Figure 18 - X-RAYS (WITH RADIO-OPAQUE DYE) OF DAMAGED SPECIMENS

A. DAMAGE AT 3534 FPS

B. DAMAGE AT 3517 FPS

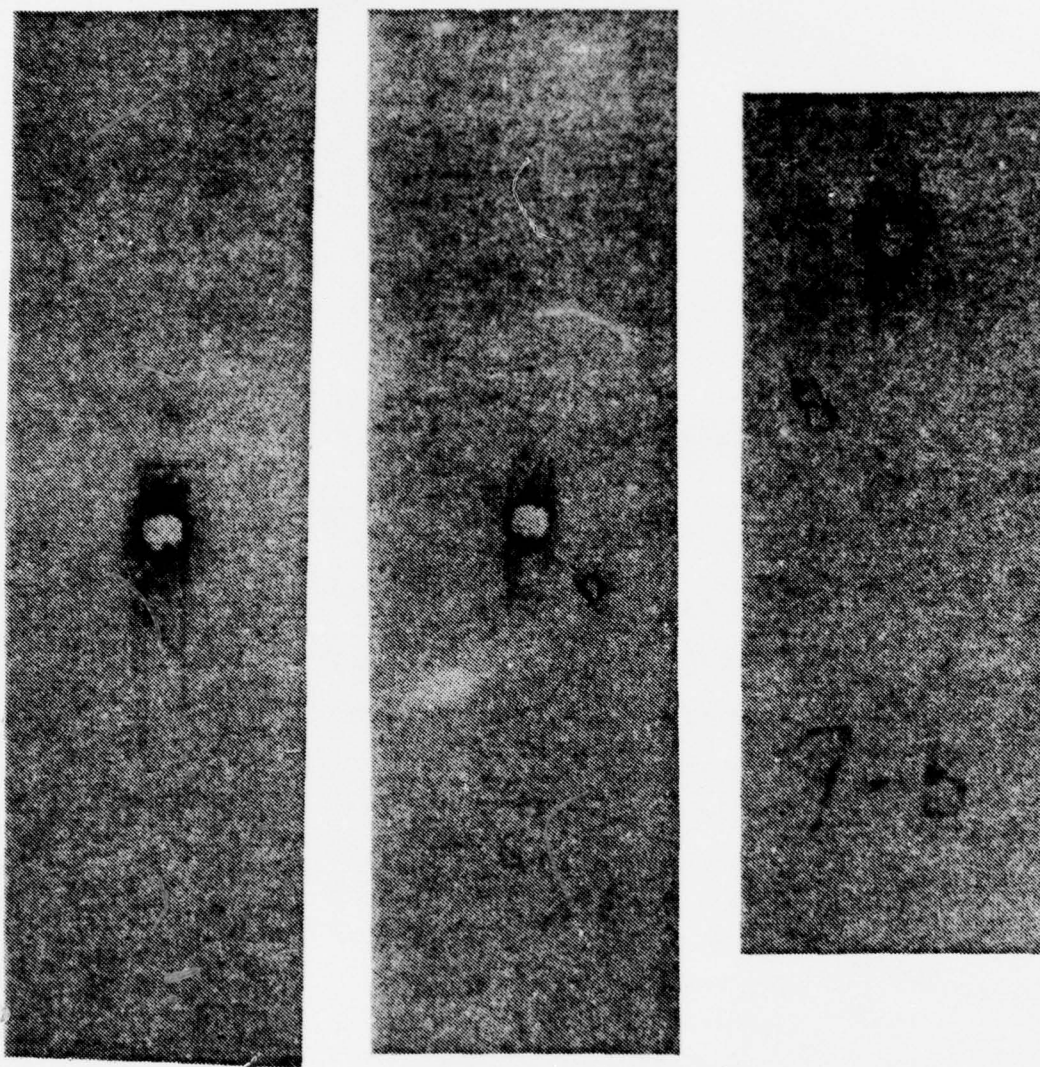
Figure 19 - X-RAYS (WITH RADIO-OPAQUE DYE) OF DAMAGED SPECIMENS

A. DAMAGE AT 4029 FPS B. DAMAGE AT 3994 FPS C. DAMAGE AT 4058 FPS

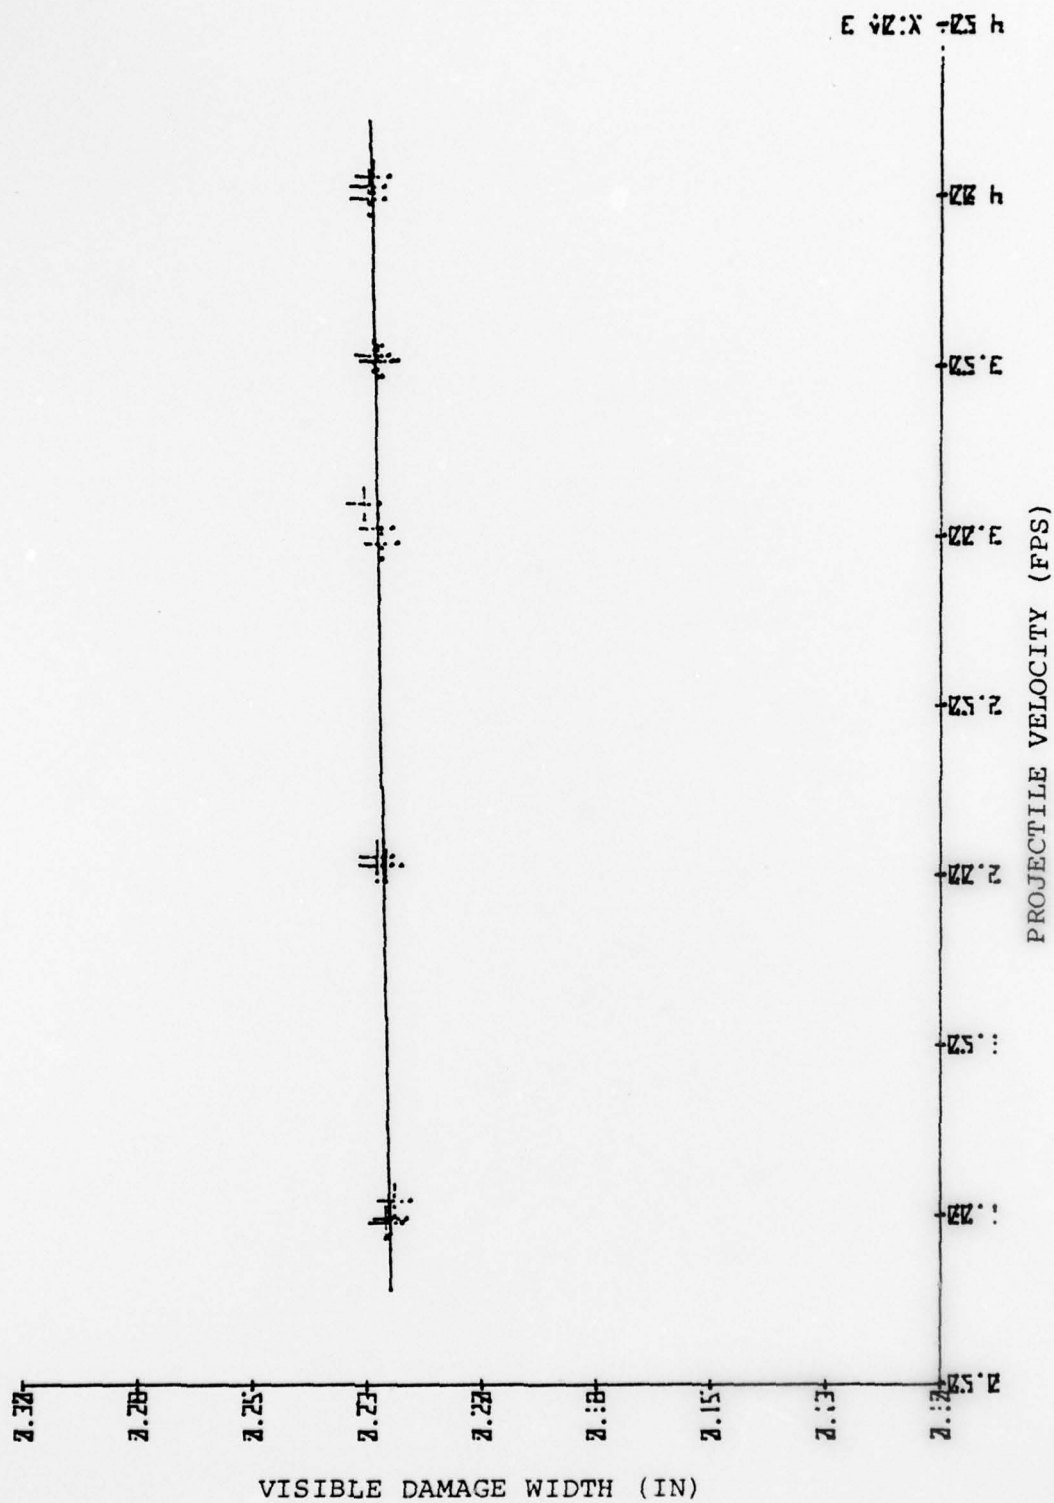
Figure 28 - PROJECTILE VELOCITY VS. VISIBLE DAMAGE WIDTH

Figure 27 plots residual strength vs. projectile velocity and shows that the residual strength is essentially independent of the velocity of the impacting projectile. Figure 28 shows the variation in visible damage width as a function of projectile velocity, while Figure 29 shows the variation in visible damage length as a function of projectile velocity. Consideration of these figures leads to the conclusion that for the specimens tested and the loading scheme (i.e., uniaxial tension) used in this test series, damage length has little or no effect on residual strength. Since projectile diameter was not varied, and velocity changes had little effect on damage width, the effect of damage width on residual strength was not determined. Changes in projectile velocity did cause changes in damage length, but as can be inferred from Figure 27, these changes in damage length did not result in changes in residual strength.
